## Technical Bulletin N°06

REFERENCE BT\_2017\_FR20\_06\_UK

SUBJECT Actuator stop screw check + tape on GPS antenna

### 1. Actuator stop screw check - Monza F.R. EURO CUP EVENT

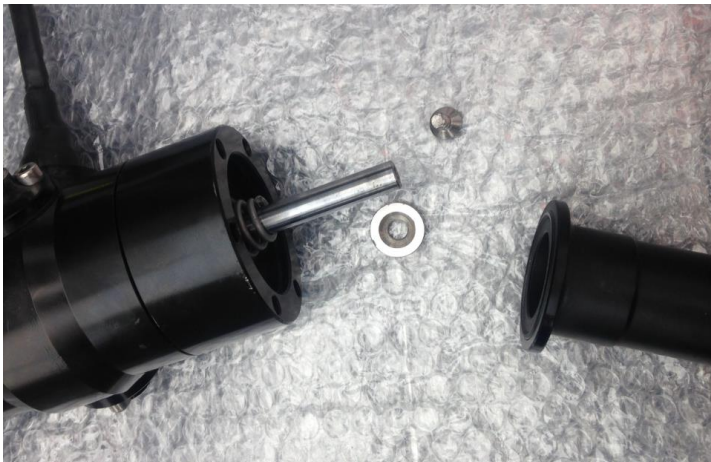
*Axle stop screw untighten: no Loctite on.*

Renault Sport Racing asks you to check the gearbox actuator axle stop screw and the return spring. In case you will not find any Loctite® on the stop screw, please apply it.

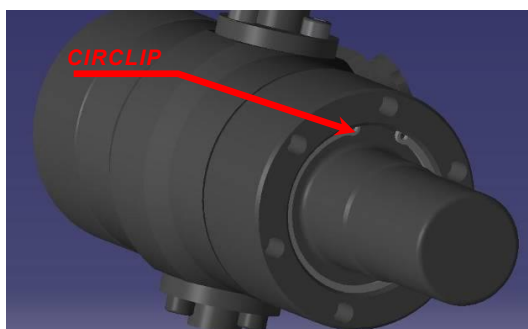
In order to check it, please remove the circlip and then the rear housing.
